**Historic Landscape Report:
Warden House
Stillwater, Minnesota**

Warden House
Stillwater, Minnesota

Ann Ebbessendorf
Graduate Student
Department of Landscape Architecture
University of Minnesota

2003

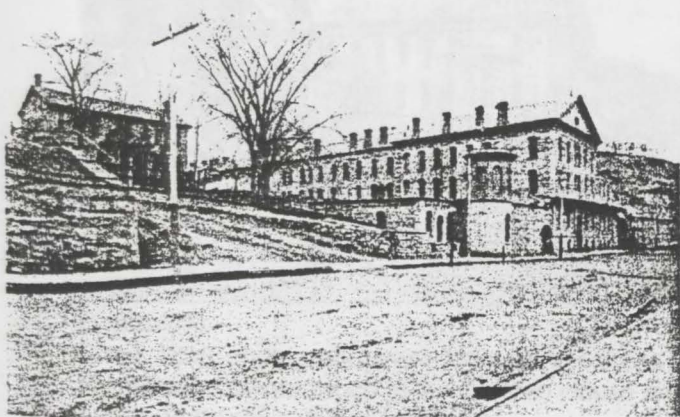
Figure 4.4

1881 photograph looking west across Main Street at the Warden House and adjacent State Prison. Note the stone house and iron fencing.

In 1881, the first known photograph of the front yard of the Warden House was taken (Figure 4.4). The landscape depicted is a vastly different portrait of what provided seven years earlier in the 1874 sketch/photograph set. The Warden House stands like a beacon against the defoliated horizon, while the imposing prison structure looms next to the front yard of the residence. Taken in either the spring or the fall of 1881, this photograph gives a clear view of the front of the property due to the absence of leaves on the trees. Many trees, possibly of a maple or elm variety, have been planted and a one-story stone house structure, which disappears in later photographs, has been built into the slope of the front yard. An iron fence encloses the yard in a random geometric shape with a central gate aligned with the front door. Curiously, a set of stairs from iron gate to the sidewalk elevation is not provided.

is no longer in existence and in this photograph the structure is clearly there. Thus, this photograph must have been taken earlier than ca. 1900. The front iron fence is still in the same configuration as the 1881 picture, although a smaller two-story porch has taken the place of the original Territorial porch. A new set of wooden stairs and boardwalk has been added to the southern edge of the property bordering Laurel Street. The limestone wall along Main Street sidewalk appears to have been reconstructed and improved. The landscape period plan dated 1881-1884 was produced during this time utilizing the previous two pictures and the Sanborn Insurance Map of 1884 (Table 1.1). The front yard is visually correct, although photographs of the backyard are not available. Thus, Laurel Street ends abruptly and a passage way to the backyard is not represented.

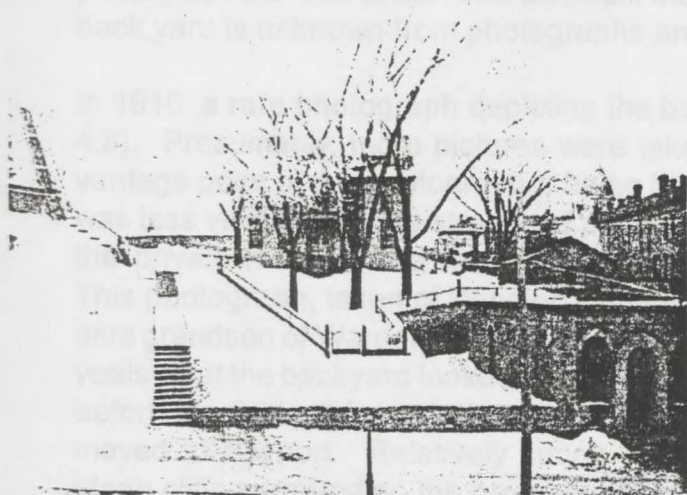
Figure 4.5

View of the Warden House looking directly west at the residence. Note the new two story porch that replaced the original. This photograph is dated as ca. 1900, but is assumed that it might have been taken earlier.

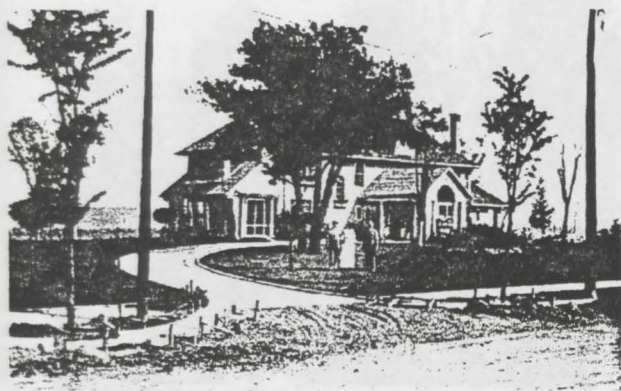
Figure 4.9
The new Warden House at Bayport, Minnesota circa 1918. Note the concrete driveway and curb and gutter being constructed.

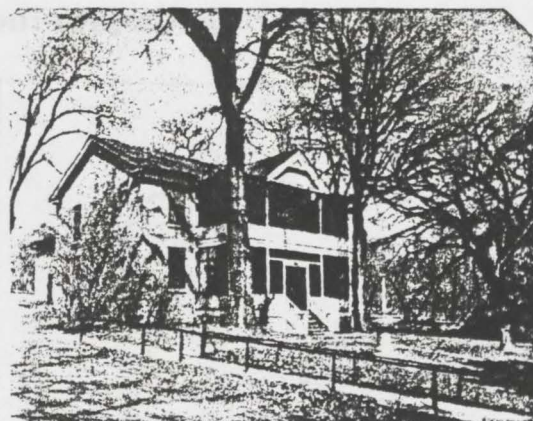
Figure 5.2

A view of the Warden House in 1969. The vegetation has matured and railing is still visible.

The next subsequent photograph from 1969 showcases the Warden House better than the 1954 image from street level (Figure 5.2). The secondary entrance with its railings is evident, although the fencing material has evolved over time. A watering trough and bell have been added to the front yard and the porch has grown larger since the early 1900's photographs.

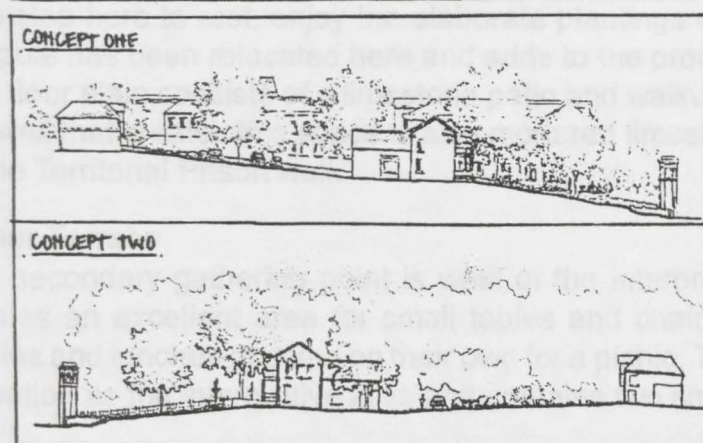
Figure 10.3

The sections at left are provided to give a sense of scale and proportion to a proposed design. The Terra Spring development is sketched in lightly to express the scale of the buildings that are currently being constructed. The slope of the site is also accurate and exemplify the extremity of the front yard. The top section is from the biomorphic concept and is facing north. The terraced gathering point is noted in the front yard. Concept two is represented beneath the top section and faces south. The gathering/dining area is noted here which is combined with an overlook to Terra Springs development.
